# **SANDIA REPORT**

SAND2008-5185  
Unlimited Release  
Printed August 2008

## **The Sandia MEMS Passive Shock Sensor: FY08 Failure Analysis Activities**

This report summarizes failure analysis activities performed on various designs of the MEMS based Passive Shock Sensor (PSS). The failure analysis activities in this report focus on identifying root cause of failures observed at both die and package levels. The findings from these failure analyses have and will lead to implementation of corrective actions focusing on maturing the MEMS-based PSS and meeting product deliverables and milestones.

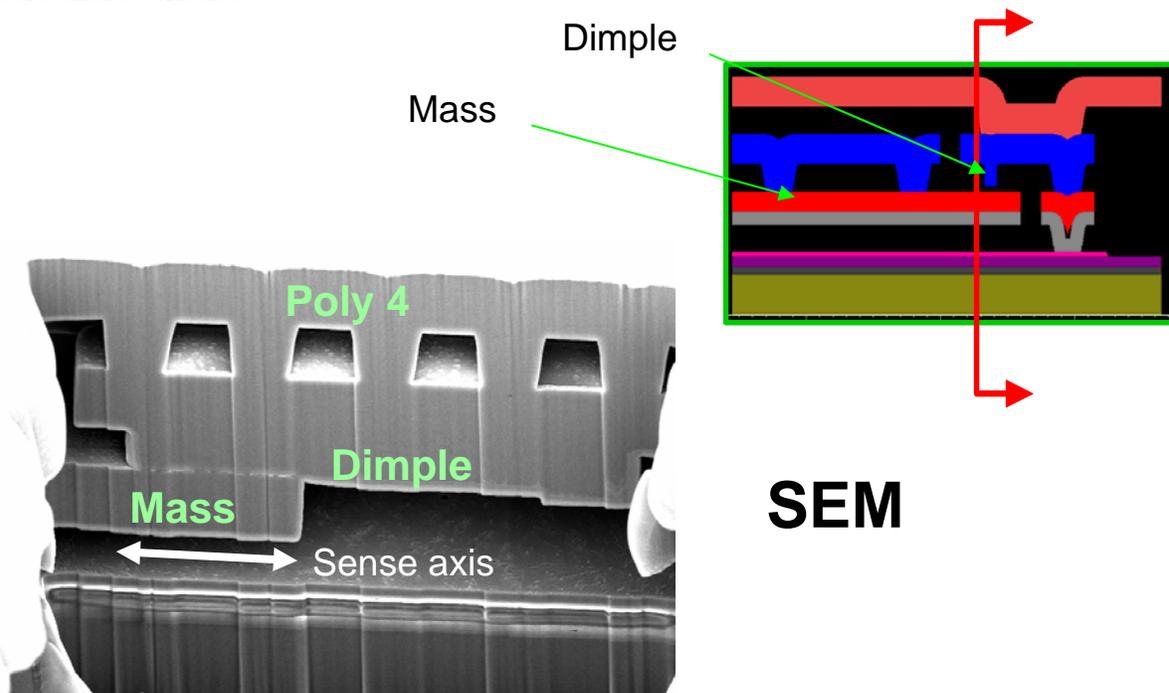
Failure analysis and design assessment of Rev 3 PSS components was performed to understand the cause of shuttle sticking. As discussed in a previous PSS report [3], the dimple 3 structure was identified as rubbing against the top portion of the moveable mass as shown in Figure 3-1. This rubbing introduced friction into the device causing the device to have altered open and closure characteristics.

Figure 3-1. Dimple contact with the moveable mass.

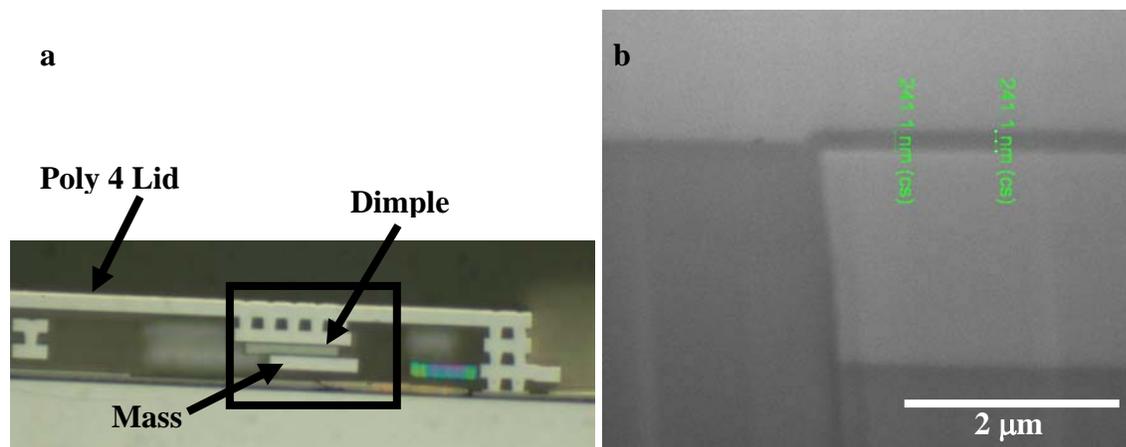
Further analysis of the same mass and dimple via FIB cross-section and mechanical cross-section showed a gap spacing of  $\sim 0.24 \mu\text{m}$  instead of the designed specification of  $0.40 \mu\text{m}$ . This reduction in gap spacing along with other potential factors such as residual stress in the surrounding polysilicon structures and z-axis deflection lead to dimple contact and rubbing.

As shown in the FIB cross-section and mechanically polished optical image in Figure 3-2, the gap spacing of  $0.24 \mu\text{m}$  is caused by insufficient backfill from the sacrificial oxide deposition process. Analysis of blank wafers subjected to the same thin-film processing showed an oxide thickness of  $0.40 \mu\text{m}$ . This result confirms the change in surface topography introduces thinning of the sacrificial oxide in the dimple region creating the smaller gap spacing. The reduced gap spacing clearly makes the PSS component more susceptible to rubbing and sticking failures and/or significantly alters the PSS sensing capabilities. These failure analysis efforts led to revised designs with no dimples, effectively increasing the gap spacing between the oxide cut and the proof mass.

**Figure 3-2. a) Optical image of a mechanically cross-sectioned as-fabricated PSS device showing the dimple in very close proximity to the moveable mass, b) FIB analysis showing an as-fabricated gap spacing of  $\sim 0.24 \mu\text{m}$ , smaller than the  $0.40 \mu\text{m}$  design.**

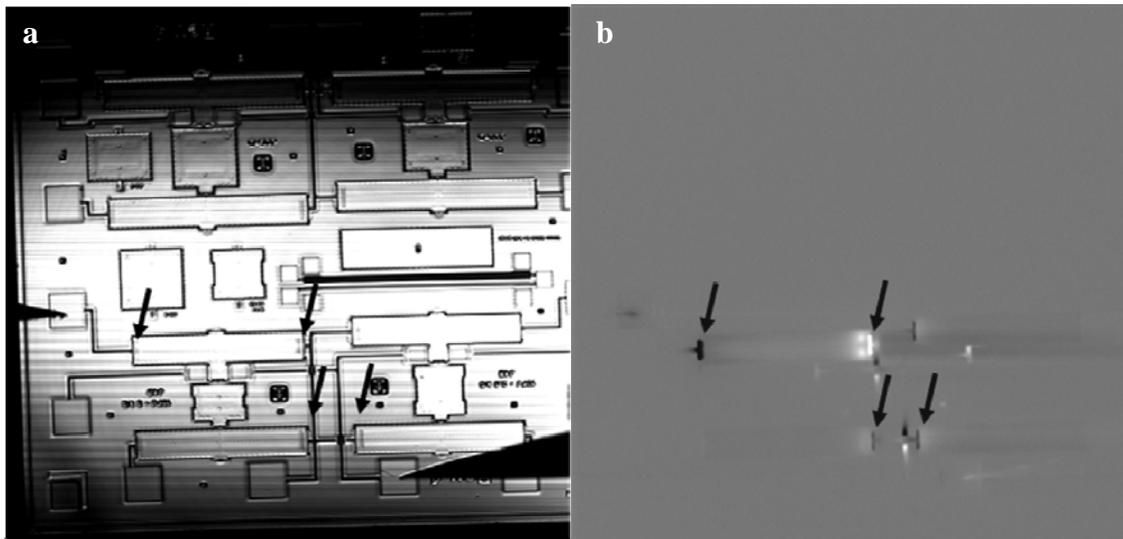
identified using a technique known as Thermally-Induced Voltage Alteration (TIVA), a failure analysis technique using a laser scanning optical microscope equipped with a 1064 nm laser. The PSS device is connected to power and ground through microprobers connected to a Keithly 238 power supply. The power supply is kept at a constant current (1  $\mu\text{A}$  for this analysis) while the 1064 nm laser scans the PSS device. The laser will locally heat the scanned region. In the case of a short, the localized heating will produce a corresponding change in resistance associated with the shorted area. This resistance change (with the power supply kept at constant current) will result in a voltage fluctuation to maintain the constant current. It is these changes in power supply demands that are imaged as a function of the laser scanning position producing the TIVA image. Results of these findings identified the location of the shorts on the PSS devices and are shown in Figure 3-3. Arrows in both the reflected light image and TIVA image denote regions of interest where shorting occurs.

**Figure 3-3. a) Reflected light image of a PSS device post metal deposition, b) TIVA image using a 1064 nm laser with 1  $\mu\text{A}$  applied bias. Note the arrows identify sites of interest where an electrical short exists.**

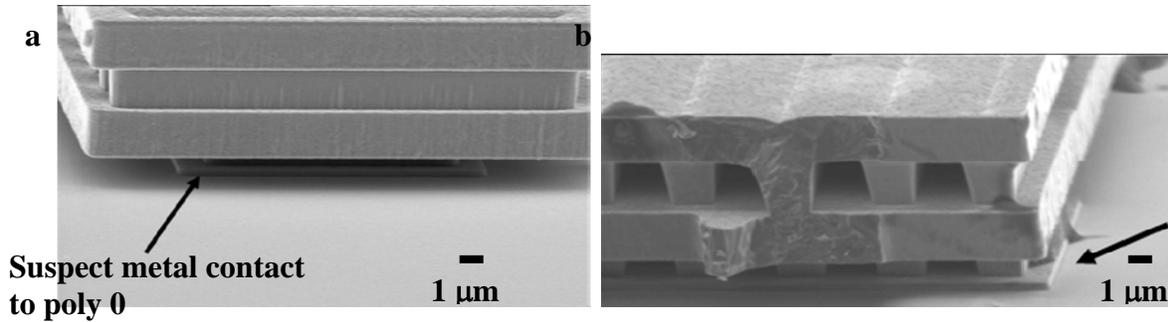
SEM analysis of these TIVA sites did not reveal any particles, metal stringers or other gross metal defects contributing to a short. However, at high tilt angle, it appears the poly 4 cover layer does not extend out far enough to sufficiently mask the underlying polysilicon structures (such as poly 0) to prevent the metal from depositing on them during deposition. These results are shown in Figure 3-4 where high-angle SEM images of a thermal actuator show metal on the sidewall of the poly 4 cover as well as metal contacting the poly 0 layer underneath. The metal penetrating underneath the poly 4 cap contacting the poly 0 layer led to the short identified in all the thermal actuators on these dice from this metal deposition process. The degree of metal penetration underneath the poly 4 cap was also studied, but clearly the penetration of metal underneath poly 4 is significantly more than anticipated in this metal deposition process.

**Figure 3-4. a) SEM analysis of a thermal actuator edge does not shadow the underlying poly 0 structure indicating metal is contacting poly 0, b) metal contact confirmed on the right portion of the image. Note the dark contrast on the bottom of the left side (absence of metal) and the bright contrast on the right side (presence of metal).**

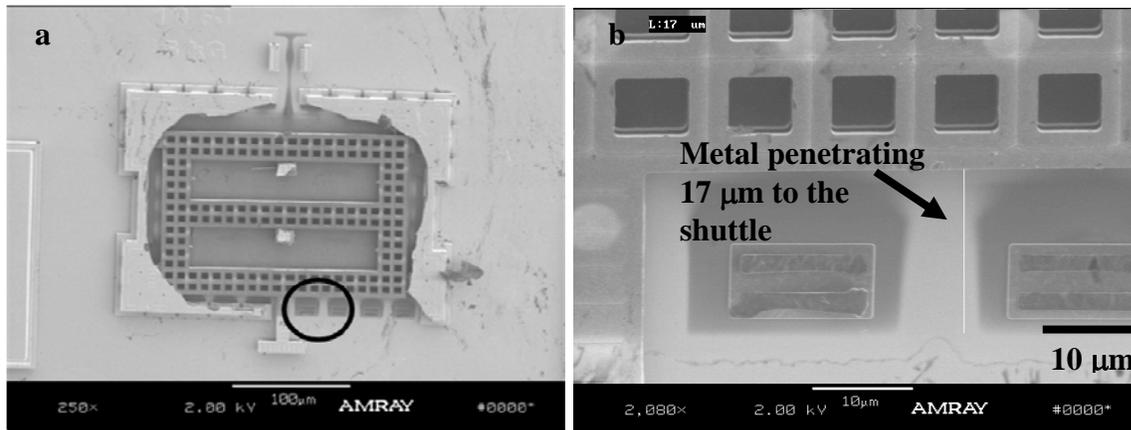
To verify the metal deposition extends deeper beneath the poly 4 cover, a cover from a PSS test structure was removed to expose the underlying proof mass and other polysilicon structures. Results of the metal deposition revealed the metal deposition extended  $\sim 17 \mu\text{m}$  underneath the poly 4 cover, significantly further than expected. In some instances, the penetration underneath the poly 4 cap is enough to reach the moveable shuttle as shown in Figure 3-5.

**Figure 3-5. a) SEM image of a poly 4 cover removed exposing a moveable shuttle, b) SEM image measuring  $17 \mu\text{m}$  of metal penetration underneath the poly 4 cover.**

The results of these failure analysis investigations led to modifications in the sputter metal deposition process and may result in slight modification of the poly 4 cover design to ensure adequate coverage of poly 0 ground planes and other electrically active structures during metal deposition.

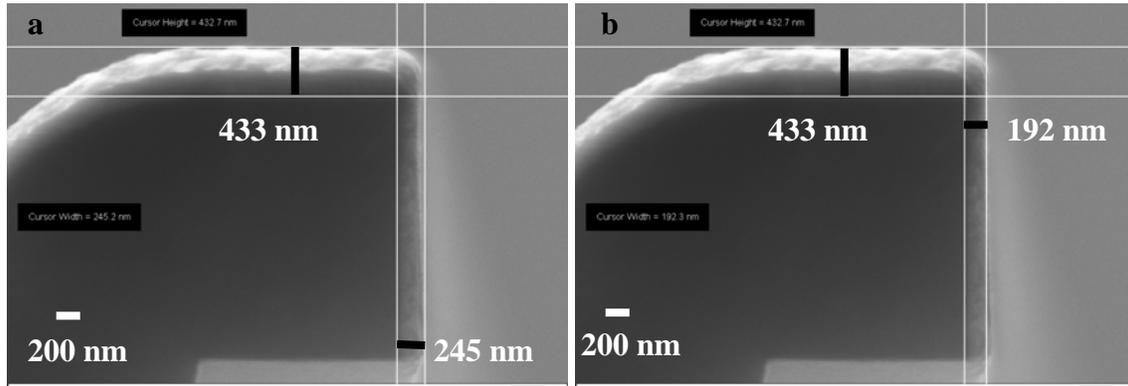
but until this time was not quantified. The contacts are exposed to the same metal deposition process and have the same metal thicknesses.

**Figure 3-6. a) SEM image showing Ti and Pt metal thickness on the top and side of a bond pad. Sidewall thickness measurement was taken at the bottom. b) SEM image with same thickness measurements but at a different location on the sidewall.**

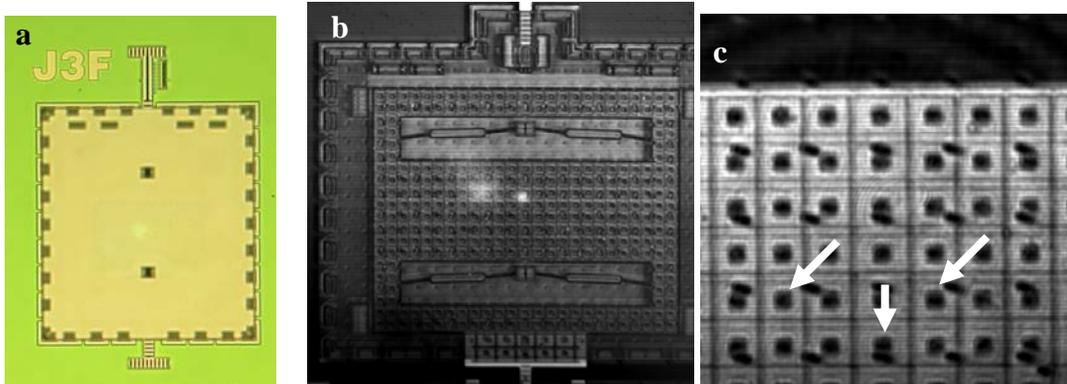
Various fabrication runs were developed to create a thicker polysilicon stacked structure for the proof mass. These runs consisted of tying poly 1, 2, and 3 together, creating a 7.5  $\mu\text{m}$  thick structure. After releasing dice containing test structures with moveable shuttles, electrical stimulus identified no movement. After electrical stimulus, the probes were applied to the extended portion of the mass to move the shuttle. The shuttles were unable to move indicating that whatever was causing them to stick was very strong. As shown in Figure 3-7, the optical image shows a stuck moveable mass in a test structure while the infrared (IR) images through the poly 4 cover (not metalized) reveal small spots inside the etch release holes of the shuttle.

**Figure 3-7. a) Optical image of a released thick poly test structure, b) IR image of a released moveable shuttle, c) small dark spots are observed inside the etch release holes of the moveable shuttle (arrows).**

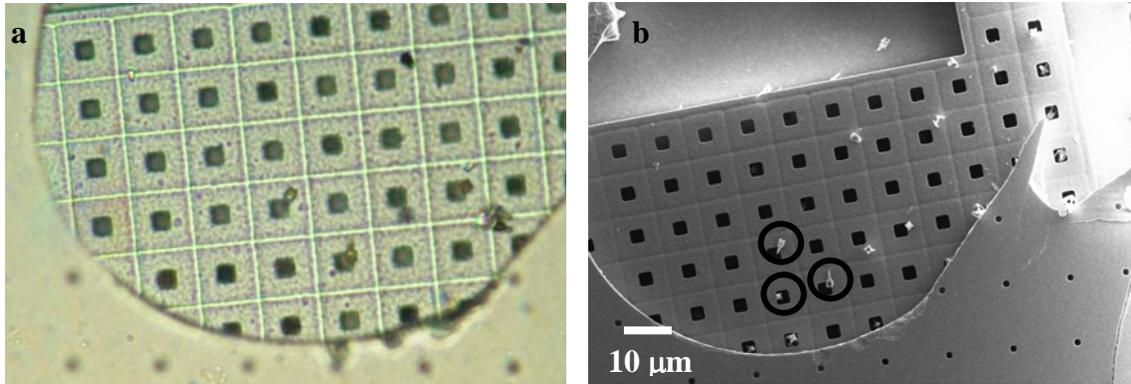
To examine the small spots further, the poly 4 cover was removed from one of the test structures. Removal of the poly 4 cover exposed several unexpected structures contained in nearly every etch release hole on the shuttle. Optical and SEM analysis confirmed they were present inside

each etch release hole. Energy dispersive x-ray analysis (EDS) taken on three of these unexpected structures confirmed the particles were silicon in origin. These structures are shown in Figure 3-8.

**Figure 3-8. a) Optical image of a moveable shuttle with the poly 4 cover removed (note the small particles in proximity to the etch release holes), b) SEM of the same area showing the structures in better detail (circle denotes EDS sample area).**

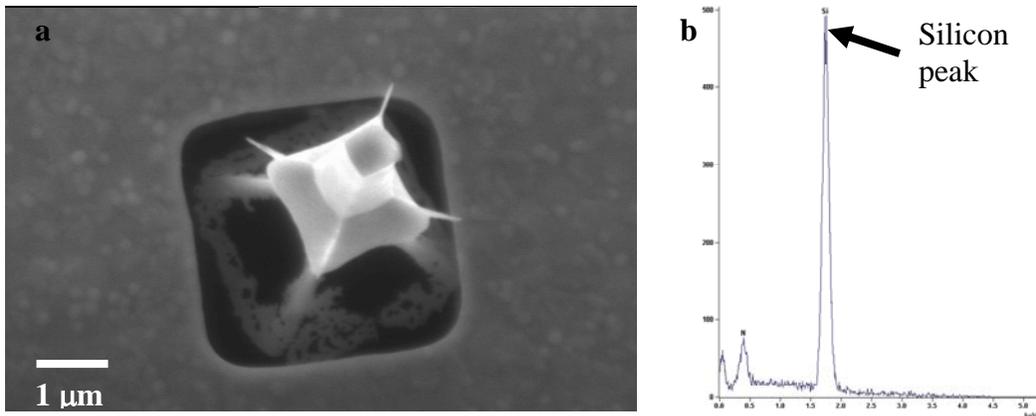
Higher magnification of the small structures shows “key-hole” defects. A released form of this defect and its corresponding EDS spectra are shown in Figure 3-9. The sacrificial oxide deposited into ordinary etch release holes in the SUMMiT process is sufficient to completely fill the hole prior to deposition of the next layer. However, in this design, the oxide did not fill the hole, leaving voids filled with polysilicon during the deposition process. This was verified using the FIB to cross-section an etch release hole in the shuttle on an unreleased part. The results from these analyses are shown in Figure 3-10. Note the failure occurred as the result of the polysilicon structure hanging from the bottom of the poly 4 cap as a “stalactite”. This structure was solidly attached to the poly 4 cap, preventing the shuttle from moving during electrical or mechanical stimulus.

**Figure 3-9. a) SEM image of the material found in an etch release hole, b) its corresponding EDS spectra indicating the particle is silicon.**

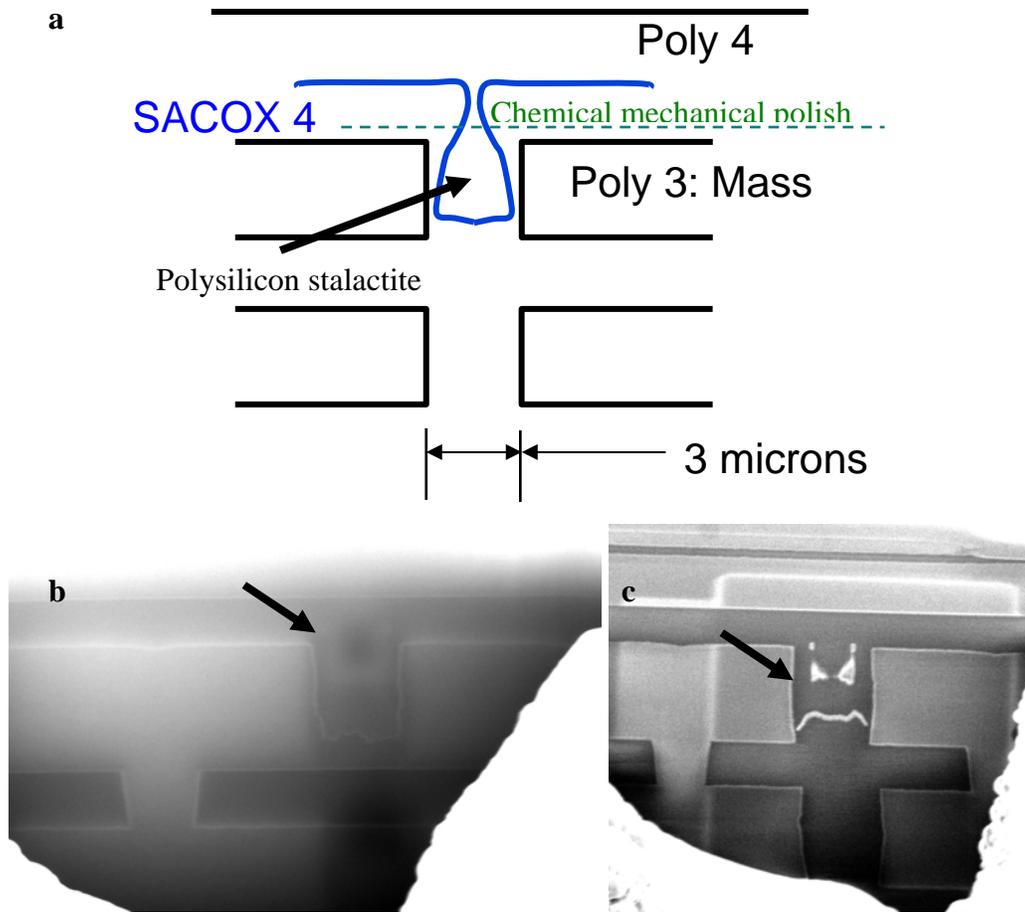
**Figure 3-10. a) Schematic cross-section illustrating key-hole defect, b) cross-section partially through the etch release hole (note the presence of the structure), and c) a cross-section  $\sim \frac{3}{4}$  through an etch release hole in the moveable shuttle showing the formation of the silicon “stalactite.”**

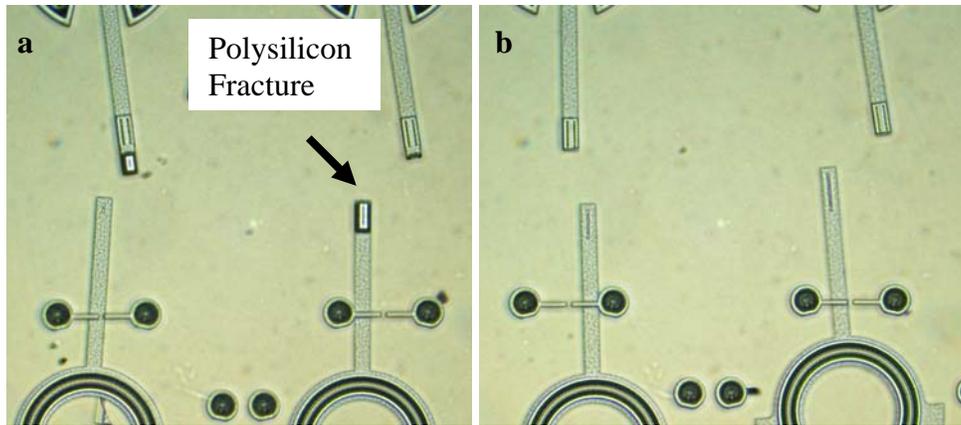
To test the mechanical robustness of the nitride anchor, a probe was placed inside the ring and pulled, putting the test structure in tension. This force was applied until failure. No measurements were taken as to the stress and strain exerted on the sample at the point of failure. After failure occurred, optical and SEM examination of the fractured surfaces were performed to identify the point of fracture. These analyses showed failure typically occurred along the nitride/polysilicon interface. One sample failed via fracture along the polysilicon. The results of these pull tests are shown in the optical images of Figure 3-12.

**Figure 3-12. a & b), Optical images showing the results of a pull test on the nitride isolation structures. Note only one sample failed at the polysilicon whereas the rest failed along the silicon nitride/polysilicon interface.**

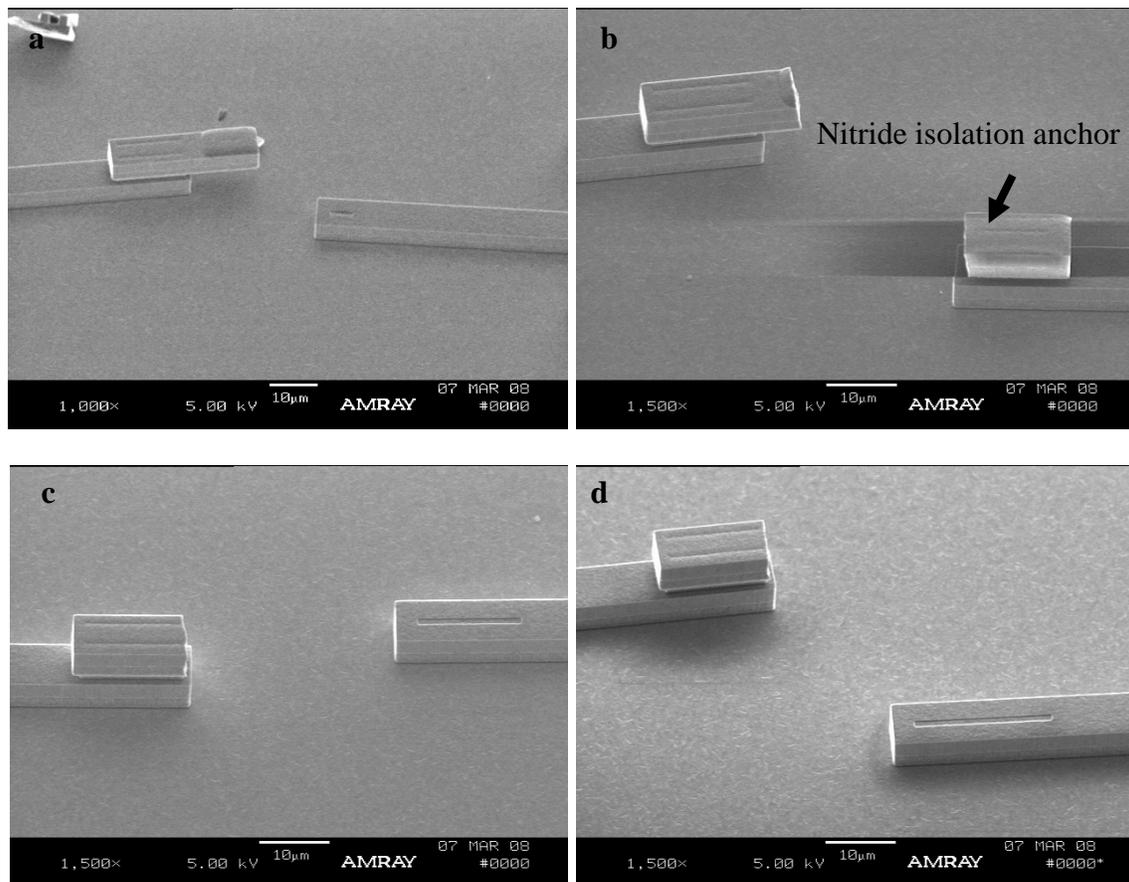
Using an SEM, closer examination of the fracture surfaces on all four test structures identified unique features on the fracture surface. As shown in Figure 3-13, the failed samples appear to show polysilicon delamination between Poly 1 & 2 and the silicon nitride. In many cases, the delamination appears “clean” indicating that the failure was along the nitride/polysilicon interface with little or no removal of underlying material. In some instances, small polysilicon crystals were broken and or removed from the poly 1 & 2 layer at the interface. These can be seen in SEM micrographs in Figure 3-14. This evidence shows that for this particular anchor design failure first occurs at the nitride/polysilicon interface.

**Figure 3-13. Fracture surfaces of test structures with silicon nitride isolation a) failure at the silicon nitride/poly interface, streaking b) fracture on the polysilicon layer, c & d) failure at the silicon nitride/poly interface.**

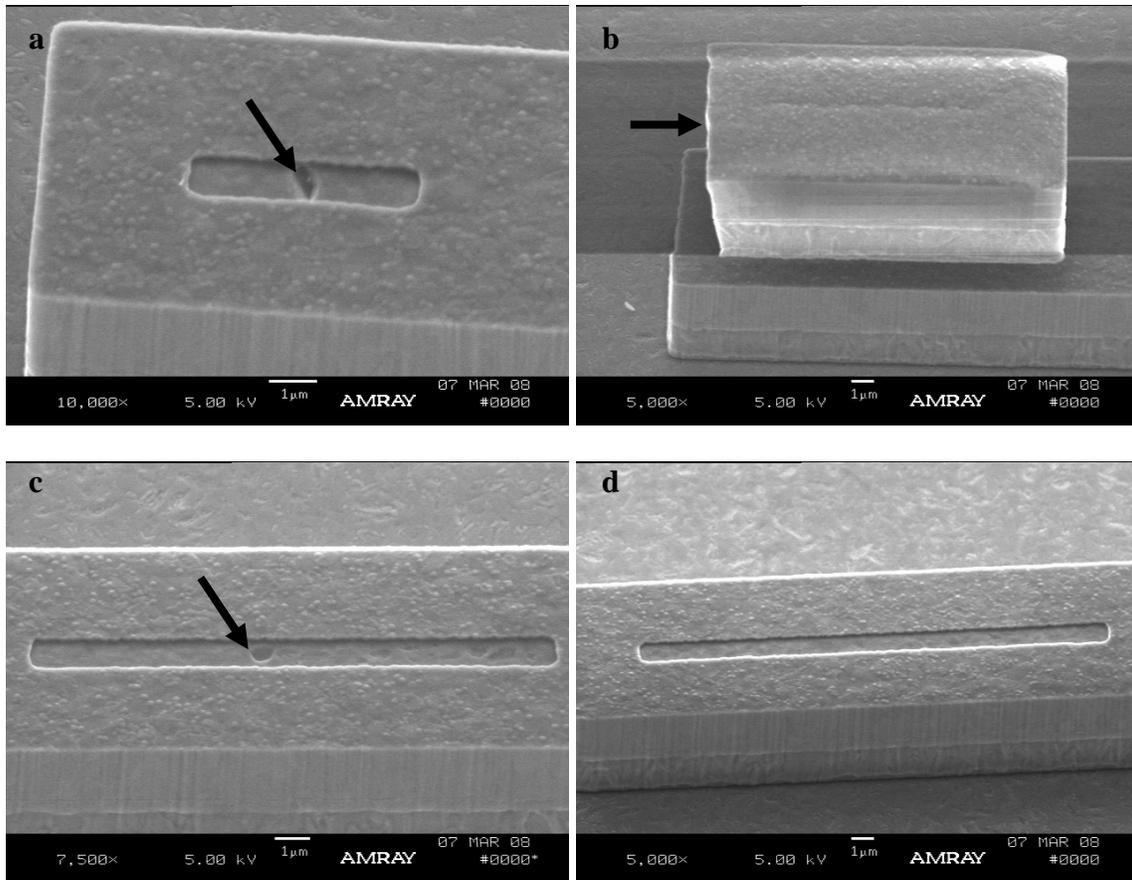
**Figure 3-14. a) Short nitride isolation cut interface with a small polysilicon grain missing indicating polysilicon delamination, b) fracture of the polysilicon with the nitride still adhered to the poly, streaking; c) nitride delamination on a 15  $\mu\text{m}$  long isolation cut (note the extruded grains), and d), nitride delamination.**

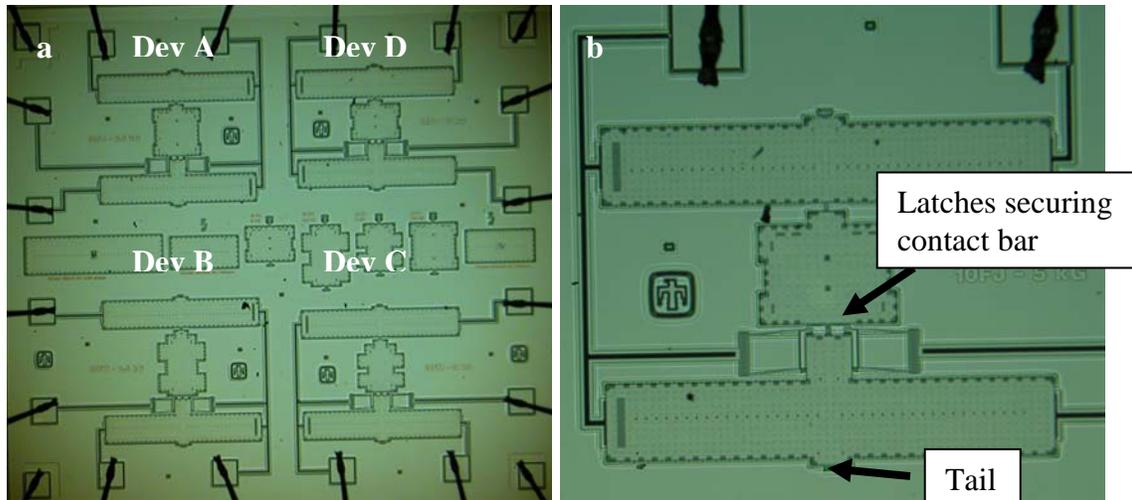
For switches that were stuck open, no irregular features or damage was identified. Visually devices stuck closed are identified by observing the contact region and noting that the contact bar is touching the contacts. Typically no damage is associated with either stuck open or stuck closed failure modes. Optical images of PSS devices failing self-test are shown in Figure 3-16. Note the small particles observed on the substrate generated from the solder ring used to keep the lid in place are ignored as they are not part of the root cause of failure. Closer analysis of the contact bar and contacts on the stuck closed failures did not reveal adhesion, welding, or sticking of these regions as the cause of failure. Exposed metal surfaces were free from contaminants and lacked any discoloration or damage consistent with any type of sticking phenomena.

**Figure 3-16. a) Delidded and exposed die from self-test, b) close-up of device D.**

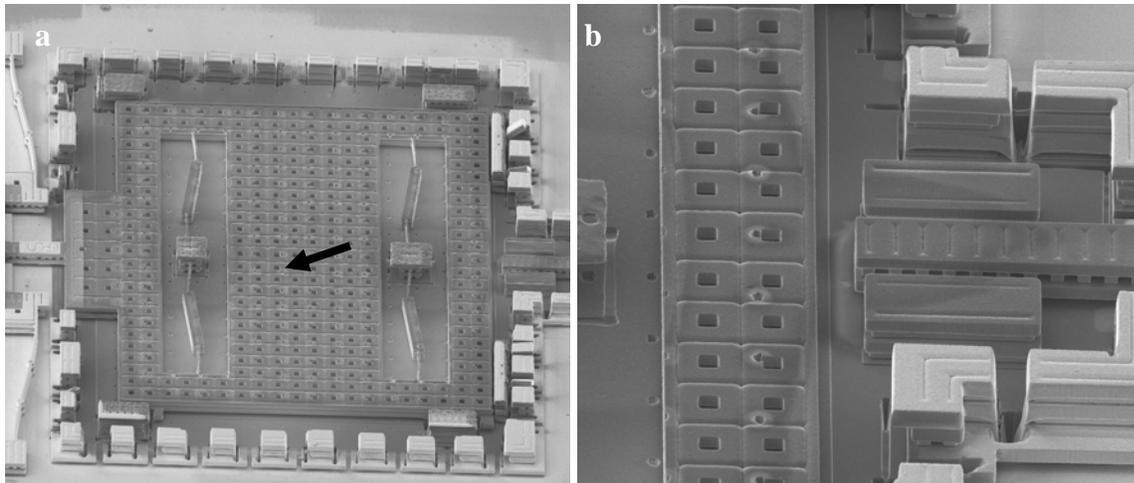
After removing the poly 4 lid, structural analysis was performed on the underlying bi-stable mass. As shown in Figure 3-18, the poly 4 cover was removed with minimal damage to the bi-stable mass. After removing the poly 4 cover, several areas of interest were examined. The mass appears to be in good structural condition, even with minor FIB damage to the spring mechanisms. Initial inspection showed the mass is still positioned in the bi-stable state, consistent with the same position it was in prior to performing the FIB cuts. Inspection of the mass and surrounding structures did not reveal any wear debris, wear tracks, or other features consistent with rubbing or contact as shown in Figure 3-18. As no defects or debris was observed, the bi-stable mass was removed to expose the underlying substrate and other structures of interest.

Figure 3-18. a) Poly 4 cover removed exposing the underlying proof mass, b) closer examination of the thermal actuator/proof mass contact.

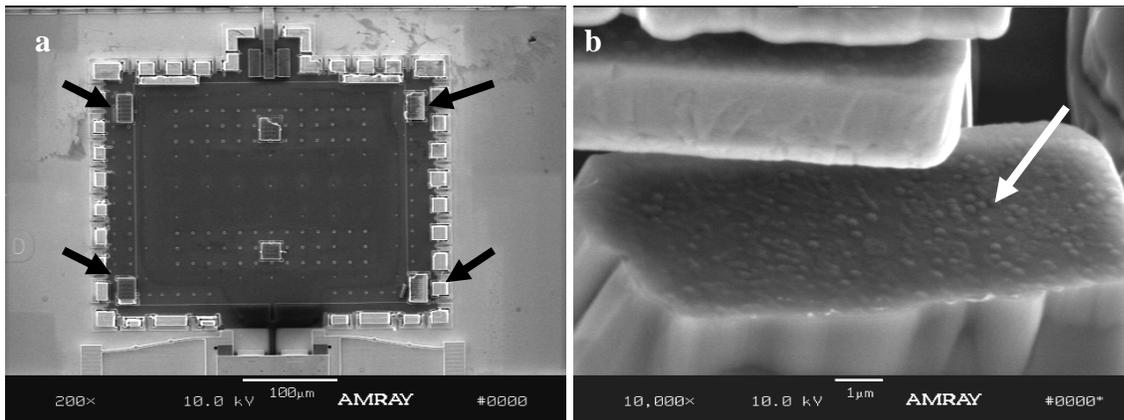
After removal of the bi-stable mass, portions of the side structures located underneath the poly 4 cover anchors were analyzed. Results of these SEM analyses shown in Figure 3-19 (a & b) did not identify damage on the top surface of the bi-stable mass or the exposed bottom surface of the anchor to poly 4. Analysis of the design in this region (Figure 3-19 a, arrows) showed a poly 1 dimple in proximity to the anchor. This dimple on the bottom of the bi-stable mass and its mirror surface on the substrate were examined. Results from these analyses showed a higher level of contrast in circular region similar in geometry to the poly 1 dimple on the bi-stable mass. This region of different contrast may be indicative of contamination in that region as shown in Figure 3-20. Unfortunately, due to the method of lift-out used to extract the bi-stable mass (probe tip with adhesive tape), we cannot confirm at this time whether the spot observed in Figure 3-20 was caused by the lift-out process extraction or whether it occurred during the test. If other failures from shock testing become available, more analysis and alternate methods of extracting the bi-stable mass will be performed to identify the root cause of failure. However,

Figure 3-19. a) Bi-stable mass removed, exposing the underlying the substrate and anchors (arrows), b) SEM analysis of the portion of the polysilicon bi-stable mass underneath the anchors (arrow), no sign of damage, rubbing, or gouging was observed.

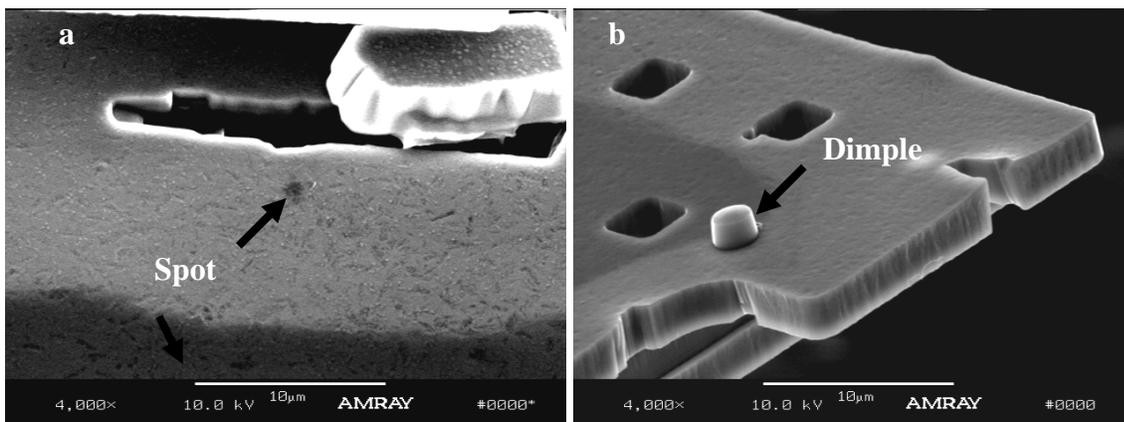
Figure 3-20. a) Possible contamination spot on the substrate coincident with the poly 1 dimple shown in b).

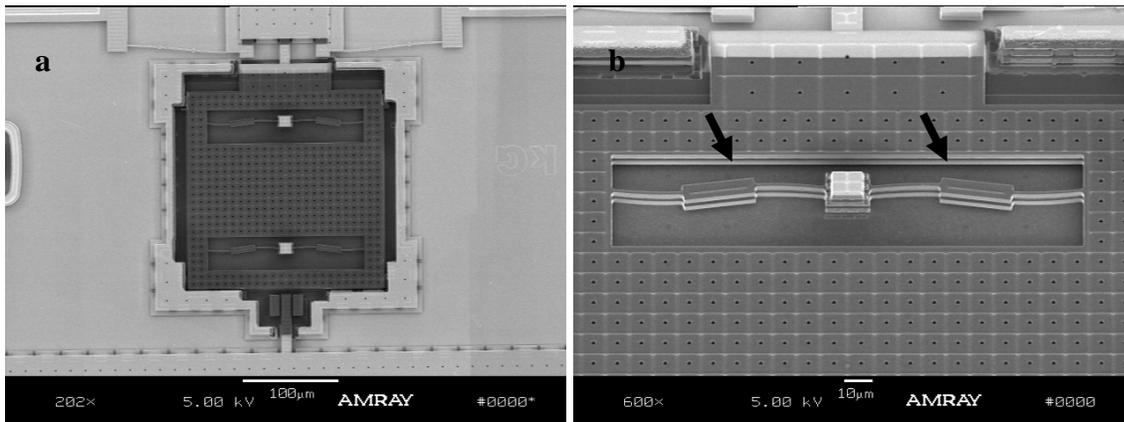
Sample X1031 failed self testing in a manner similar to the shock test sample. The same failure analysis methodology was used to examine this device with and without the poly 4 cap. Analysis of this device (not shown) did not aid in identifying the root cause of failure, but dynamic analysis indicated both thermal actuators operated correctly, indicating the problem lies somewhere within the bi-stable mass. As with the failed shock tested part, the poly 4 cover was removed for inspection and analysis. No obvious damage or structural degradation was observed and the device was still in the bi-stable position (as-received) after FIB deprocessing as shown in Figure 3-21. Analysis of the metal contacts did not show any contamination, welding or other defects. After removal of the poly 4 cover, the device was actuated and little to no movement was observed in the mass during operation. Failure analysis on self-test failed samples is ongoing. Also see Figure 3-22.

**Figure 3-21. a) Self-test sample X1031 with the poly 4 cover removed, and b) close-up view of the bi-stable mechanism.**

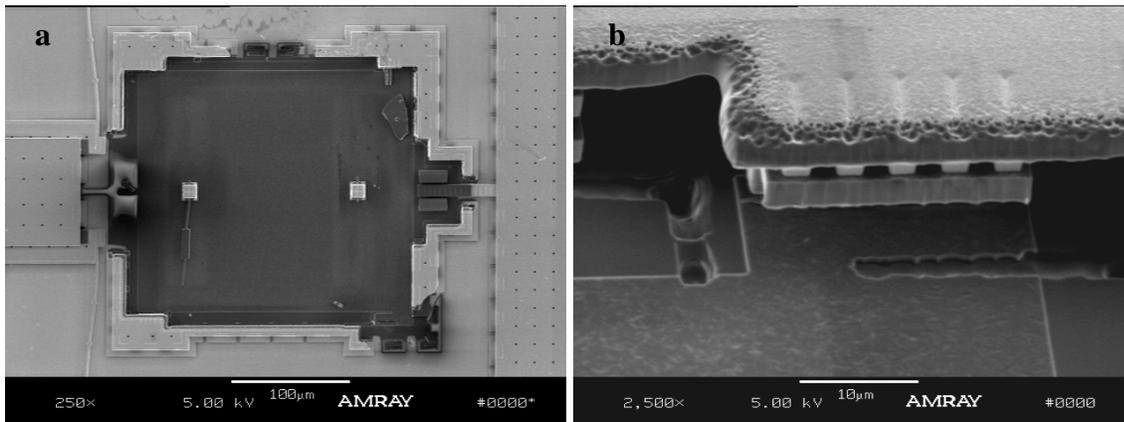
**Figure 3-22: a) Bi-stable mass removed exposing the substrate, and b) analysis near an anchor did not reveal any dark spots.**

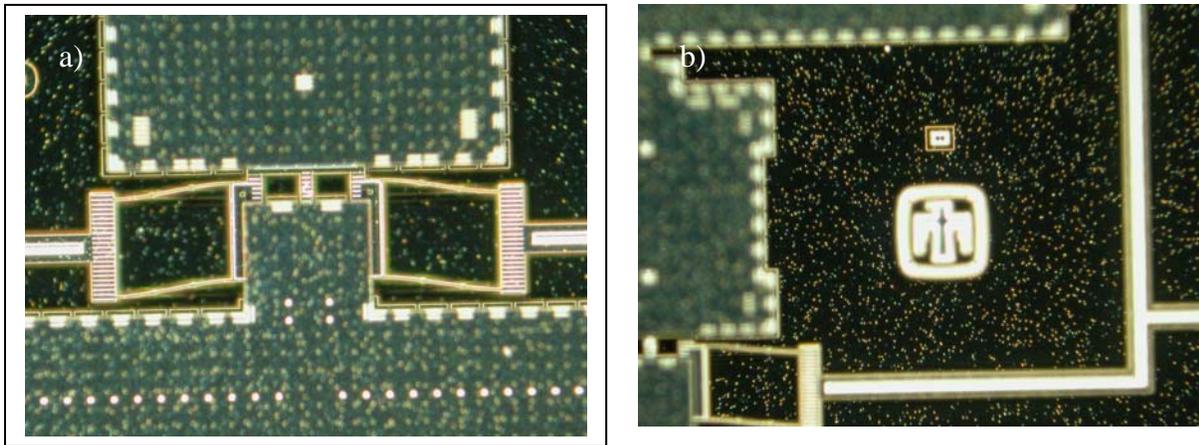
**Figure 3-23. a & b) Dark Field optical microscopy exposing contamination on the substrate of a thermally tested PSS component.**

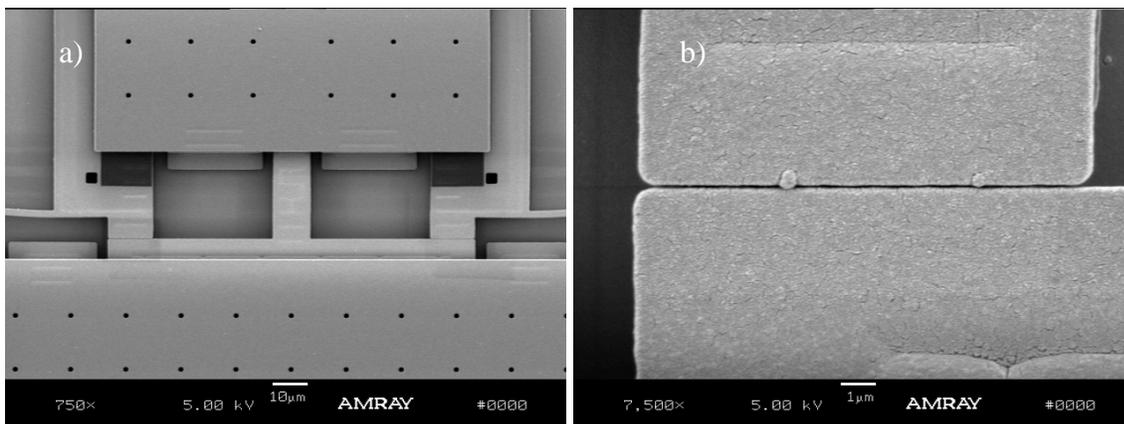
**Figure 3-24. a & b) SEM analysis of contacts did not reveal any welding or other defects.**

After the poly 4 cover was removed, the PSS device was tested to examine any potential sticking areas. This test showed the bi-stable mass did not move when pushed using the thermal actuator. Closer analysis did not show welding or damage leading to the root cause of failure, so the bi-

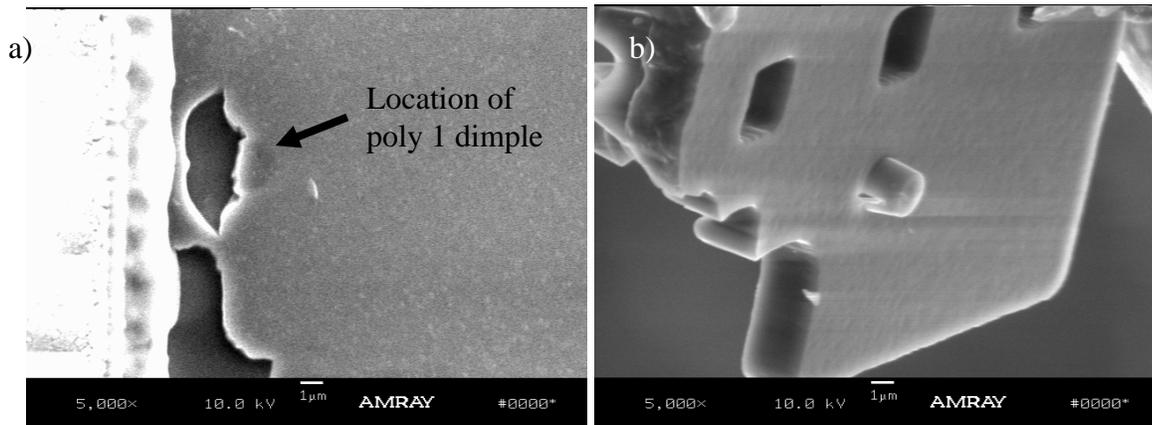
stable mass was removed to examine the underlying substrate. It was speculated that the contamination identified on the substrate and top surface of the exposed poly 4 may be diffusing underneath the cover and bi-stable mass. Removal of the poly 4 cover and the bi-stable mass revealed some material on the underlying substrate in proximity to an FIB deprocessed location, but no clear accumulation of material. As shown in Figure 3-25, the substrate underneath the bi-stable mass appears to have a small dark spot located in the same region as the poly 1 dimple on the bottom of the bi-stable mass. This dark contrast may be the result of contamination build up bridging the substrate to the poly 1 dimple. In many cases, when devices fail self-test, slightly higher voltage applied to the thermal actuators results in more force and displacement. This additional force is often sufficient to “free-up” a stuck bi-stable mass from its failing position. Although the evidence is not conclusive at this time, we believe these dark spots represent areas of contamination accumulation that bridge up to the poly 1 dimple. This “sticking” creates additional friction and may or may not prevent the PSS device from operating correctly. We speculate this may be occurring at this time. More failed samples are needed to validate the theory and additional devices are needed to perfect the poly 4 cover removal and bi-stable mass removal process.

**Figure 3-25. a) SEM image of the poly 0 substrate underneath the bi-stable mass showing a small dark spot coincident with the poly 1 dimple location, b) poly 1 dimple on the bottom of the bi-stable mass.**
