# **SANDIA REPORT**

SAND2008-5185  
Unlimited Release  
Printed August 2008

## **The Sandia MEMS Passive Shock Sensor: FY08 Failure Analysis Activities**

This report summarizes failure analysis activities performed on various designs of the MEMS based Passive Shock Sensor (PSS). The failure analysis activities in this report focus on identifying root cause of failures observed at both die and package levels. The findings from these failure analyses have and will lead to implementation of corrective actions focusing on maturing the MEMS-based PSS and meeting product deliverables and milestones.

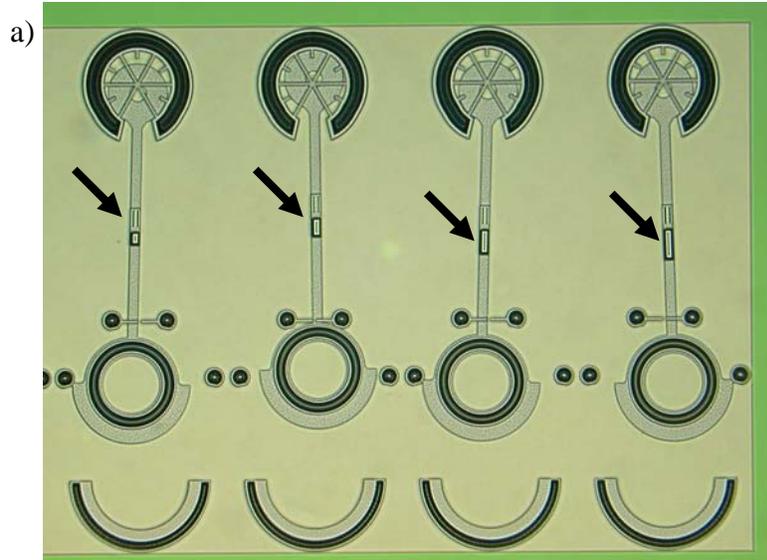
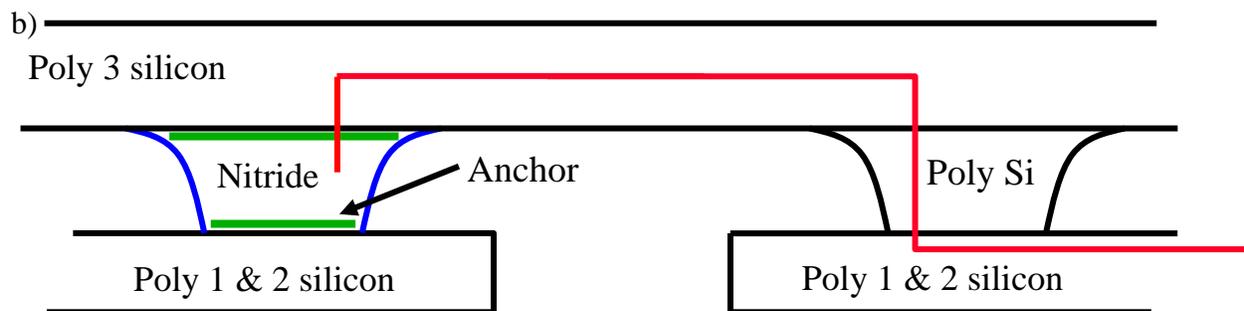
In an effort to electrically isolate various regions of the PSS device, various dimple cuts were made and backfilled with silicon nitride. Revision 3 of the MEMS dice utilizes an isolating nitride layer to prevent the alternate current path discussed in [3]. The nitride backfill was designed using dimple cuts that are traditionally backfilled with polysilicon. In this case, dimple cuts were backfilled with silicon nitride creating silicon nitride anchors. These nitride backfilled anchors mechanically connect poly 1 and 2 to poly 3. A micro-tensile test structure designed with these nitride-based anchors is shown in Figure 3-11 along with a schematic illustrating the electrical isolation. In these structures, the nitride cuts vary in length. The objective of the test was to identify a failure site, not gauge the stress and strain required to induce failure or determine the level of electrical isolation provided by the nitride cut.

**Figure 3-11. a) Nitride isolation dimple cuts on tensile test structures. Arrows indicate the nitride dimple cut and backfill; b) Schematic of nitride isolation anchors which mechanical tie Poly 1 & 2 to Poly 3 (red line indicates electrical path isolation of left Poly 1 & 2 from Poly 3).**

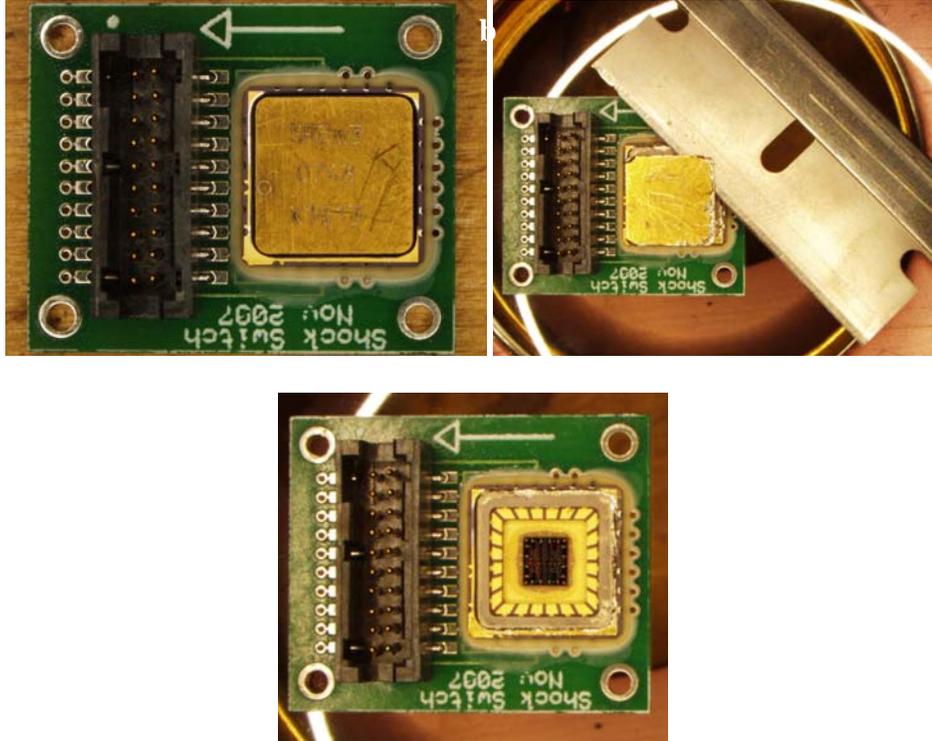
Several methods were used to aid in localizing the failure site and diagnosing the root cause of failure. For board-level and packaged parts, electrical analysis identified the parts that required further analysis. After the failure was verified, a small razor blade, a hammer, and a vice were used to stabilize the packaged part and remove the lid from the solder ring. This lid removal process allowed the failure analyst to gain access to the die for static and dynamic visual inspection. This process is shown in Figure 3-15 a-c.

**Figure 3-15. Delidding procedure demonstrated on a) PSS mounted on a board, b) razor blade perforating the seal along the lid/solder ring, and c) lid removed exposing the die.**

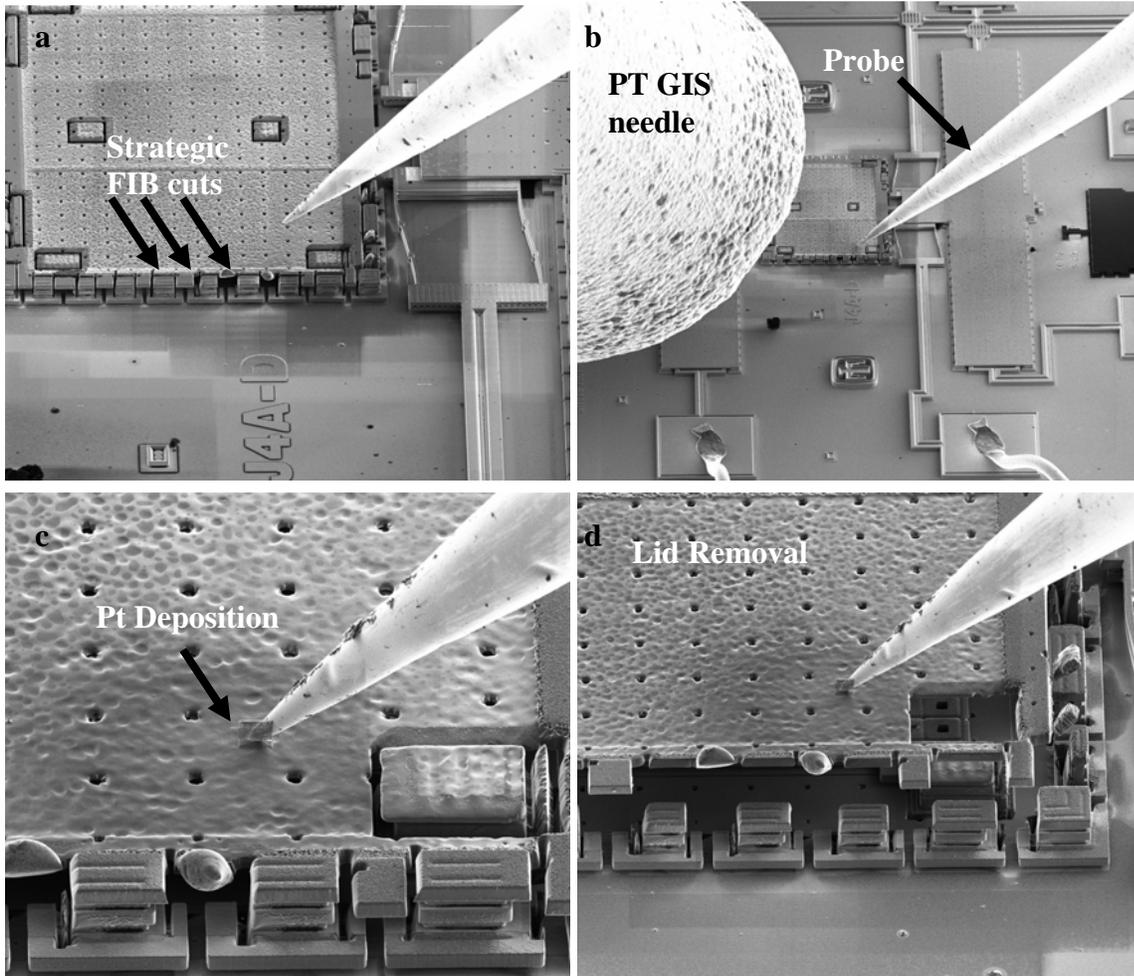
One approach that proved successful in removing the poly 4 cap with little to no damage to the bi-stable mass involved using the FIB in conjunction with an in-situ probe. The FIB was used to strategically cut a pattern around the poly 4 cover. For this process to be successful, FIB cuts were positioned around the interior of the anchors holding the poly 4 cover in place. Once the cuts were made, an in-situ probe was positioned on the cut portion of the cover. Once contact was made, a gas insertion system (GIS) containing Pt was brought in proximity to the probe and poly 4 cover. Pt was locally deposited onto the probe and poly 4 cover, “welding” the probe to the cover. After the “welding” process was performed, the probe and welded poly 4 cover were excised from the device, exposing the underlying bi-stable mass. Images detailing this process are shown in Figure 3-17.

Figure 3-17. Poly 4 cover plate removal process by a) strategic FIB cut layout, b) Pt GIS insertion, c) Pt deposition, and d) lid removal. Lid removed on part X1043.
